Chafe Protection For Onboard Systems Please

Written by Ed Sherman

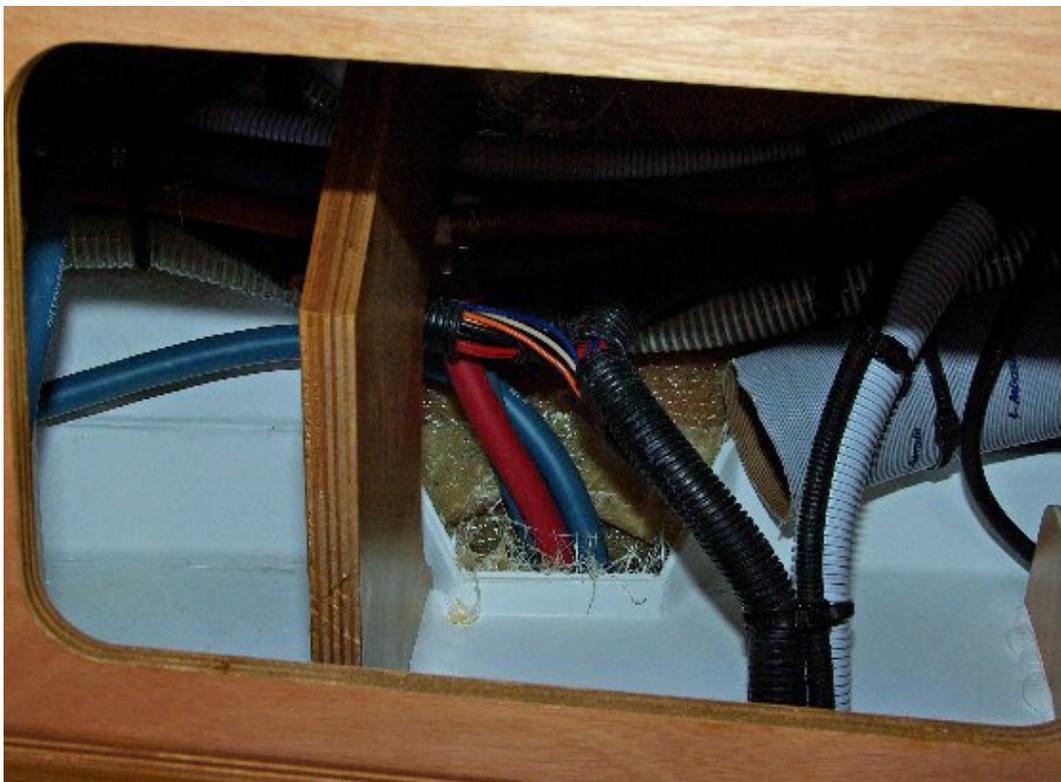
Anyhow, the photo below is one from the "It Makes Me Crazy" collection. What you are seeing is a collection of hoses and a wiring loom routed behind some cabinetry. I can't remember who's boat this was taken on, but the careful attention to detail this builder exhibited I'm certain did not get them into the winner's circle among the boats we tested and inspected that particular year. Check it out:

If you look carefully you'll notice the red and black hoses as they travel downward through the molded in opening in the lower center of the picture. If you look carefully you will see a bunch of brownish "fuzz" along the top edge of the cutout. What you are looking at are razor sharp fiberglass strands that are resinated and quite stiff, rubbing directly against the hoses. This view not only looks a bit messy, it is a spot where chafe on the hoses will occur over not too much time. Its a workmanship issue. Really sloppy workmanship. I don't know what runs through those hoses, and don't really care either. All I do know is that the hoses will fail long before their normal life expectancy is reached because of chafe against this really sharp fiberglass edge.

So boat builders, please, take the extra 60 seconds you might need to trim and fair this edge so you don't send me to the crazy house! Much appreciated.
